In-situ Bioremediation of Chlorinated Hydrocarbons

An Assessment of Projects in California

California Department of Toxic Substances Control
Office of Pollution Prevention and Technology Development

February 2006

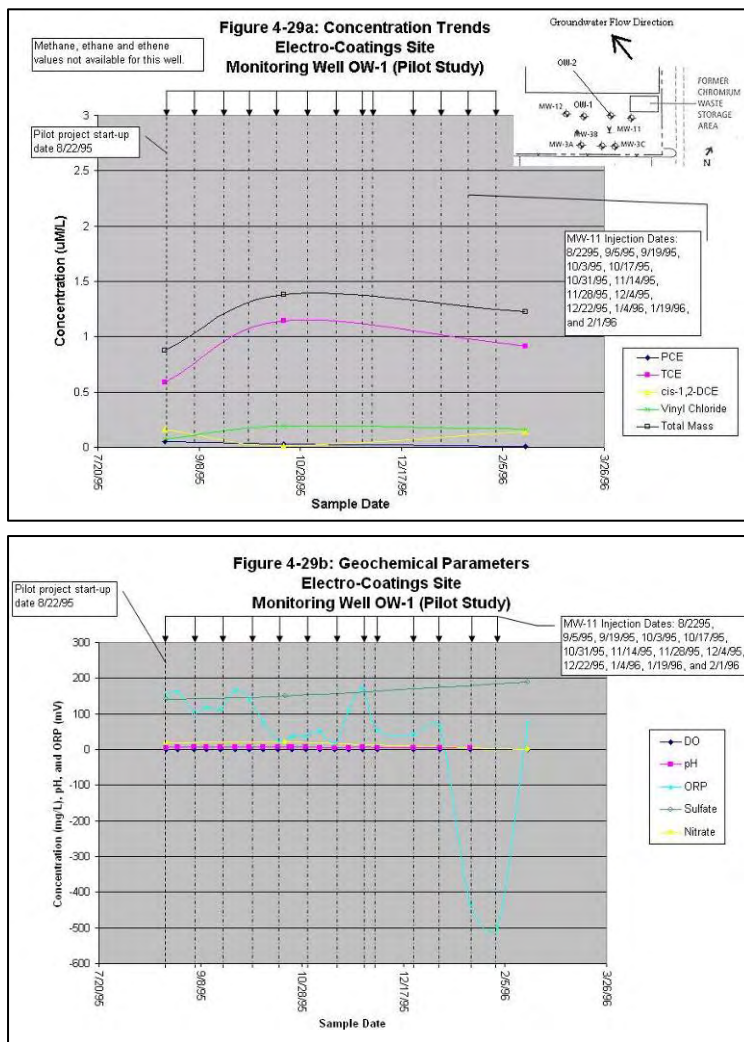
Figure 4-29. Data Analyses for Pilot Study:OW-1 at the Electro-Coatings Facility

Well Number	Contaminant Mass Loss				Enhanced Geochemical Conditions	Increased Dissolved Gases	Evaluation Rating
	PCE	TCE	DCE	VC			
OW-1	0	0	0	0	+		SE

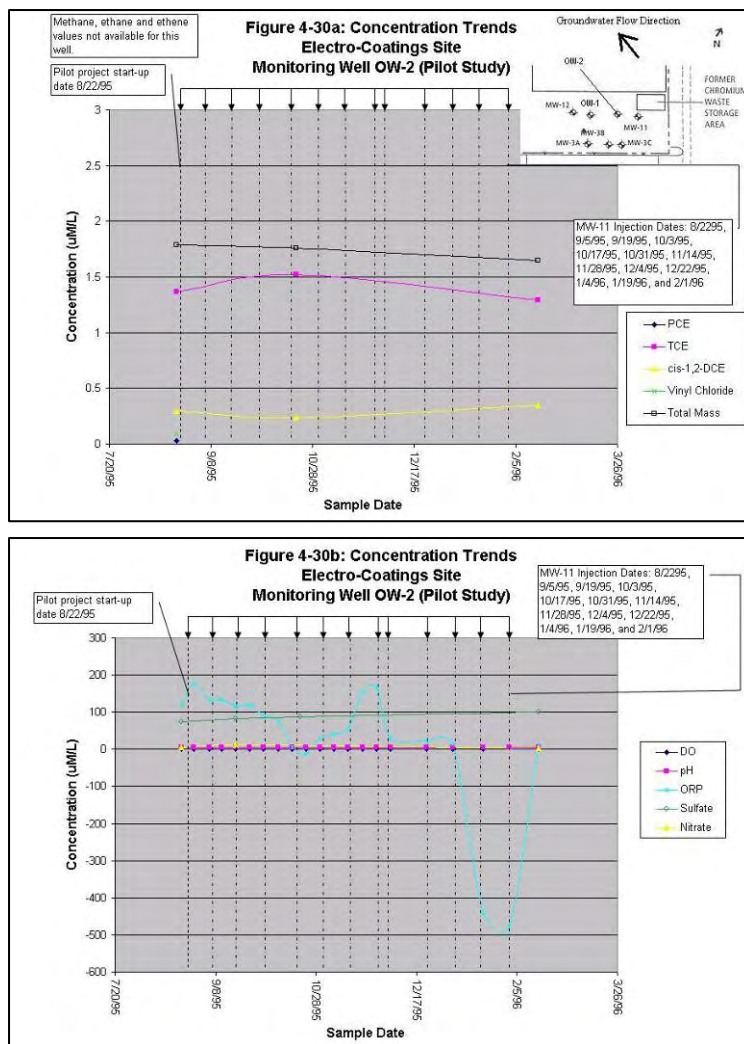
Figure 4-30. Data Analyses for Pilot Study:OW-2 at the Electro-Coatings Facility

Well Number	Contaminant Mass Loss				Enhanced Geochemical Conditions	Increased Dissolved Gases	Evaluation Rating
	PCE	TCE	DCE	VC			
OW-2		0	0		+		SE

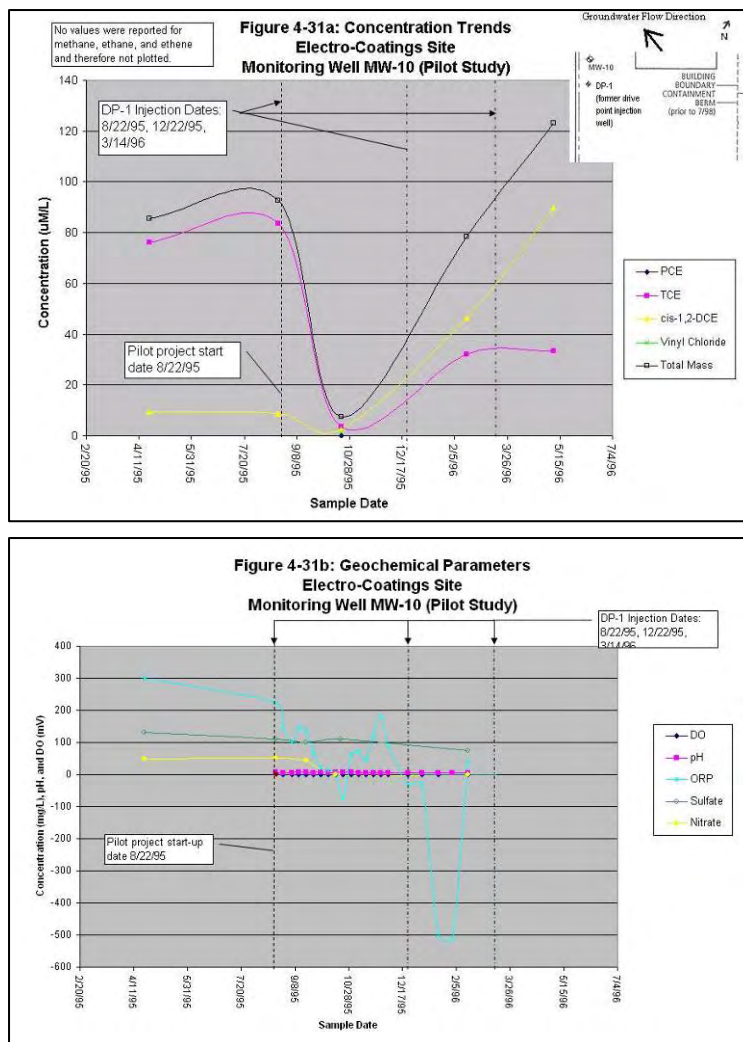
Figure 4-31. Data Analyses for Pilot Study: MW-10 at the Electro-Coatings Facility

Well Number	Contaminant Mass Loss				Enhanced Geochemical Conditions	Increased Dissolved Gases	Evaluation Rating
	PCE	TCE	DCE	VC			
MW-10		+	+		+		ME

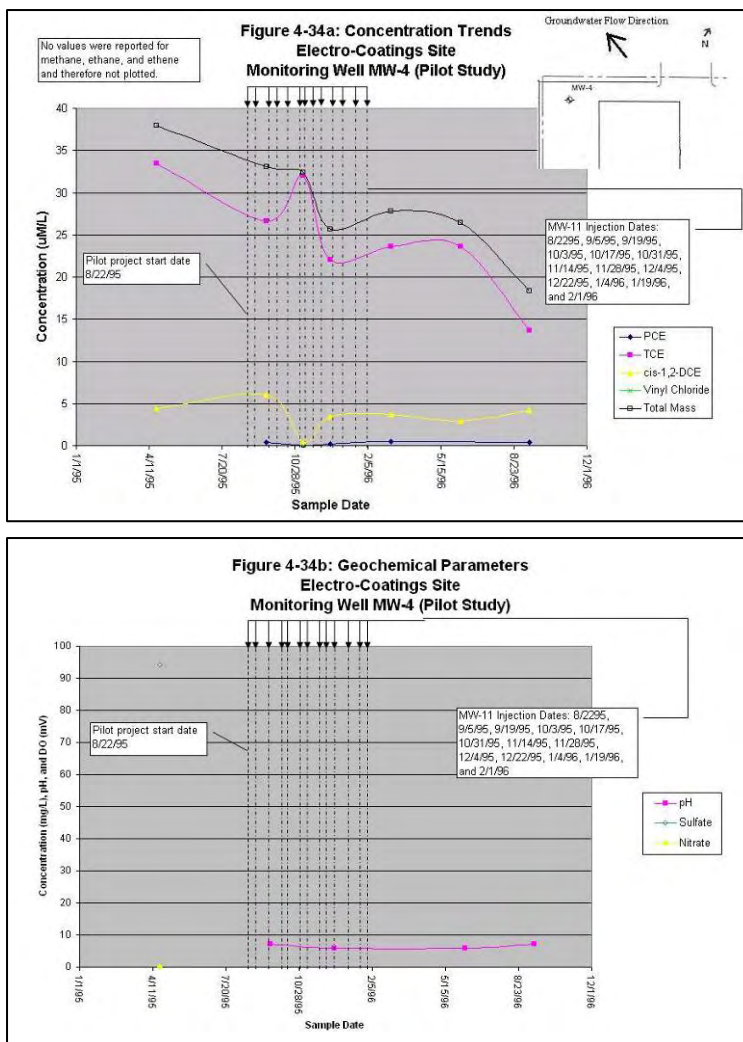
Figure 4-34. Data Analyses for Pilot Study: MW-4 at the Electro-Coatings Facility

Well Number	Contaminant Mass Loss				Enhanced Geochemical Conditions	Increased Dissolved Gases	Evaluation Rating
	PCE	TCE	DCE	VC			
MW-4	0	+	+				SE

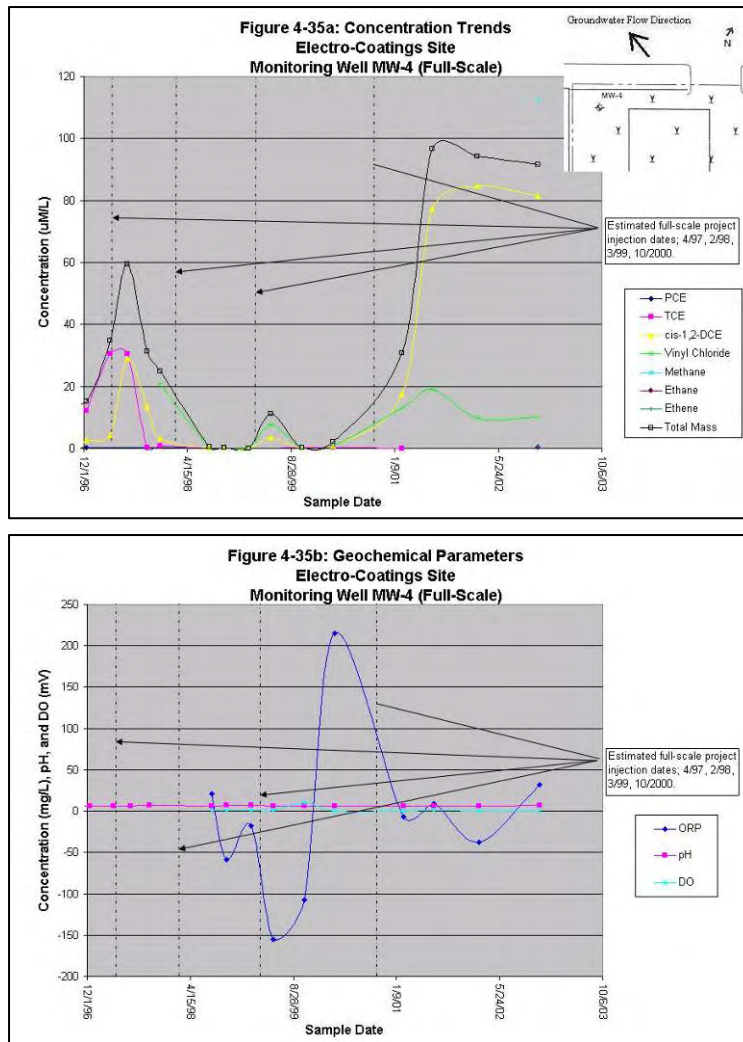
Figure 4-35. Data Analyses for Full-Scale System: MW-4 at the Electro-Coatings Facility

Well Number	Contaminant Mass Loss				Enhanced Geochemical Conditions	Increased Dissolved Gases	Evaluation Rating
	PCE	TCE	DCE	VC			
MW-4	0	+	+	+		-	SE

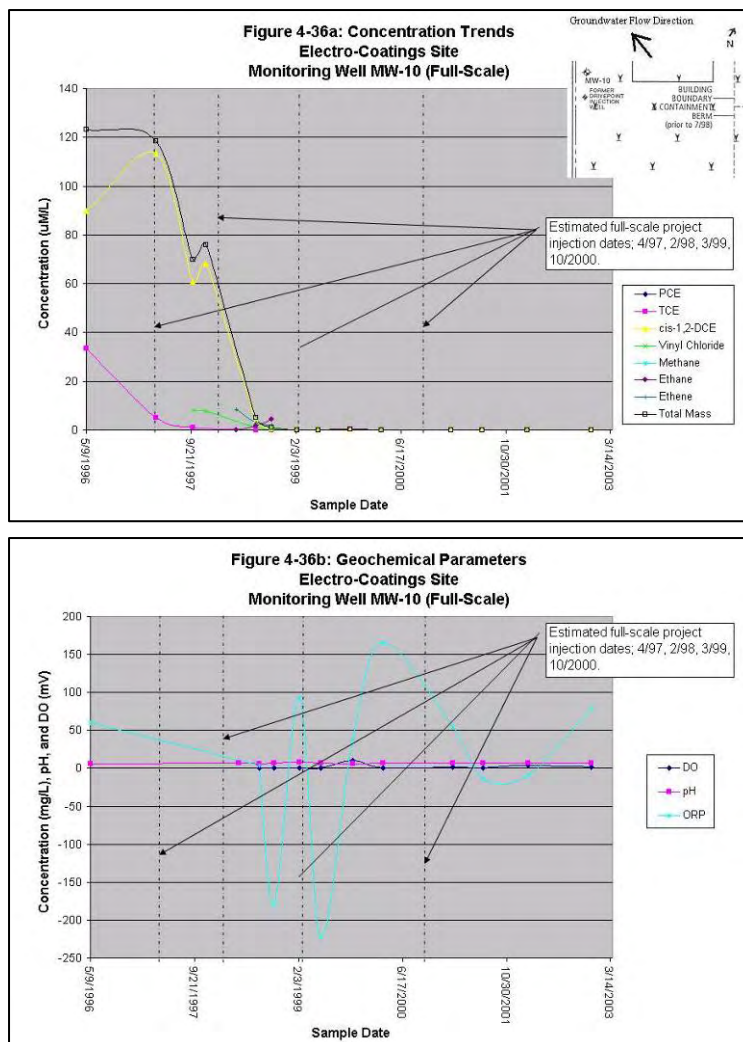
Figure 4-36. Data Analyses for Full-Scale System: MW-10 at the Electro-Coatings Facility

Well Number	Contaminant Mass Loss				Enhanced Geochemical Conditions	Increased Dissolved Gases	Evaluation Rating
	PCE	TCE	DCE	VC			
MW-10	0	+	+	+		+	ME

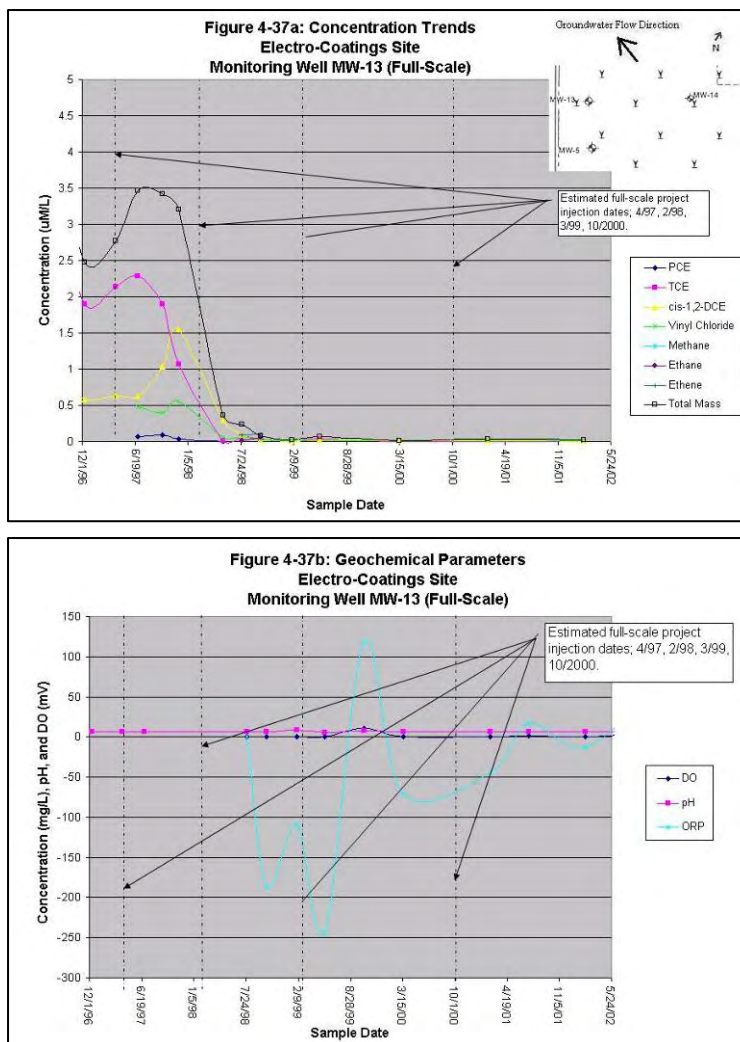
Figure 4-37. Data Analyses for Full-Scale System: MW-13 at the Electro-Coatings Facility

Well Number	Contaminant Mass Loss				Enhanced Geochemical Conditions	Increased Dissolved Gases	Evaluation Rating
	PCE	TCE	DCE	VC			
MW-13	+	+	+	+		+	ME

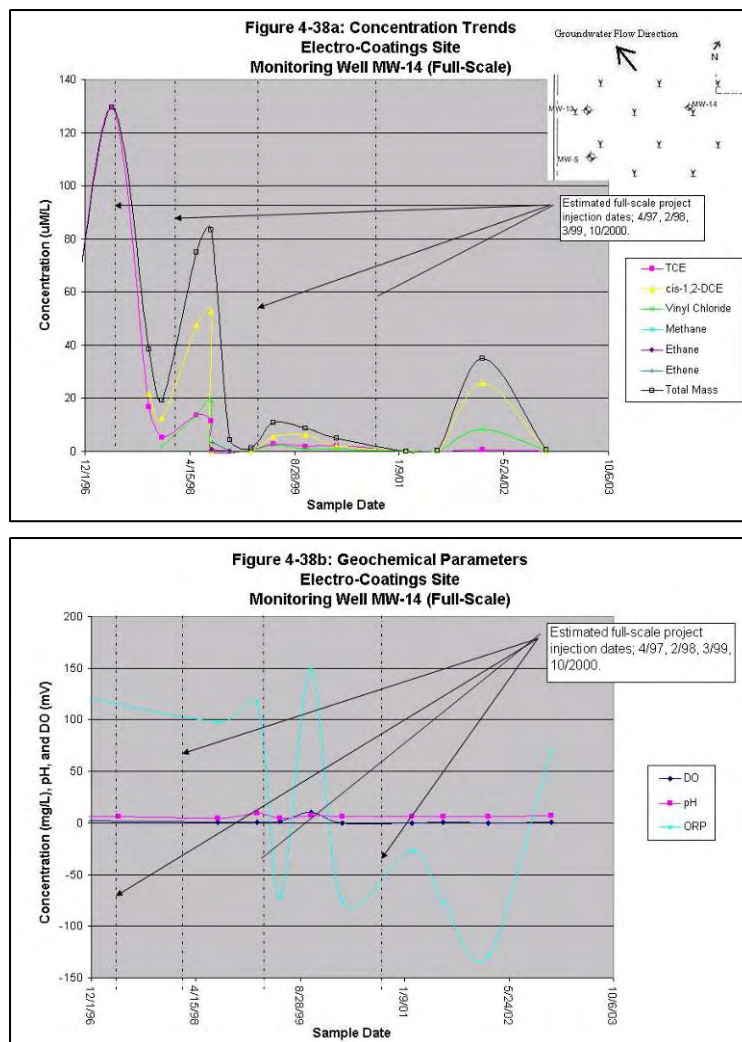
Figure 4-38. Data Analyses for Full-Scale System: MW-14 at the Electro-Coatings Facility

Well Number	Contaminant Mass Loss				Enhanced Geochemical Conditions	Increased Dissolved Gases	Evaluation Rating
	PCE	TCE	DCE	VC			
MW-14		+	+	+		-	SE

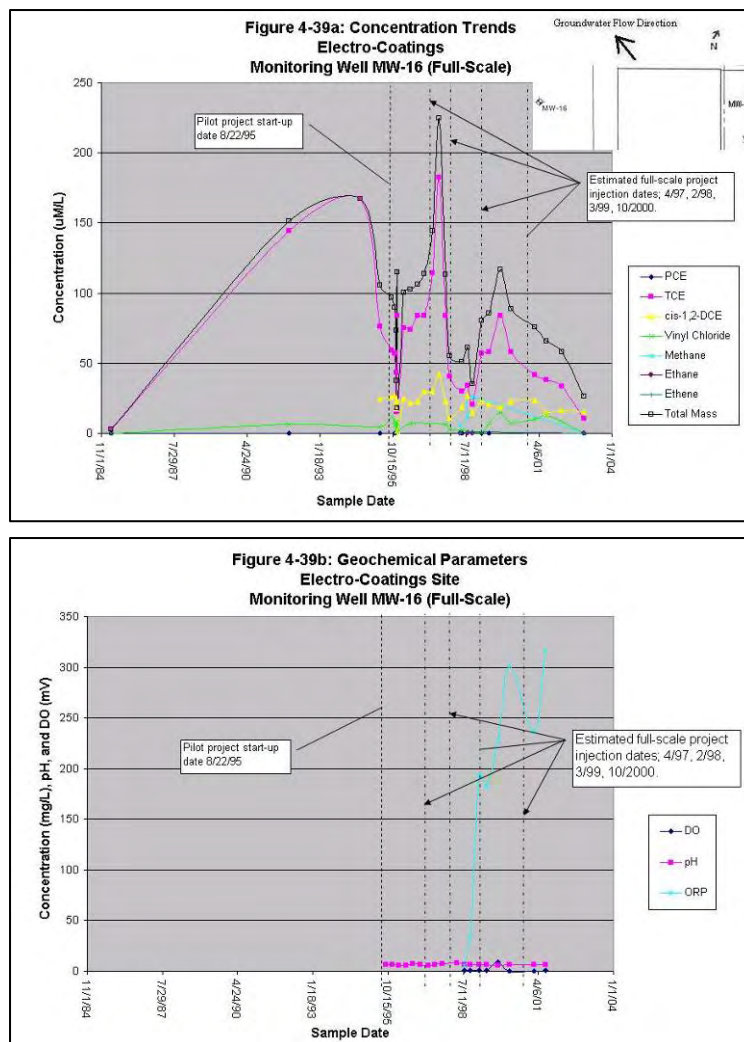
Figure 4-39. Data Analyses for Full-Scale System: MW-16 at the Electro-Coatings Facility

Well Number	Contaminant Mass Loss				Enhanced Geochemical Conditions	Increased Dissolved Gases	Evaluation Rating
	PCE	TCE	DCE	VC			
MW-16	0	+	+	+		-	SE

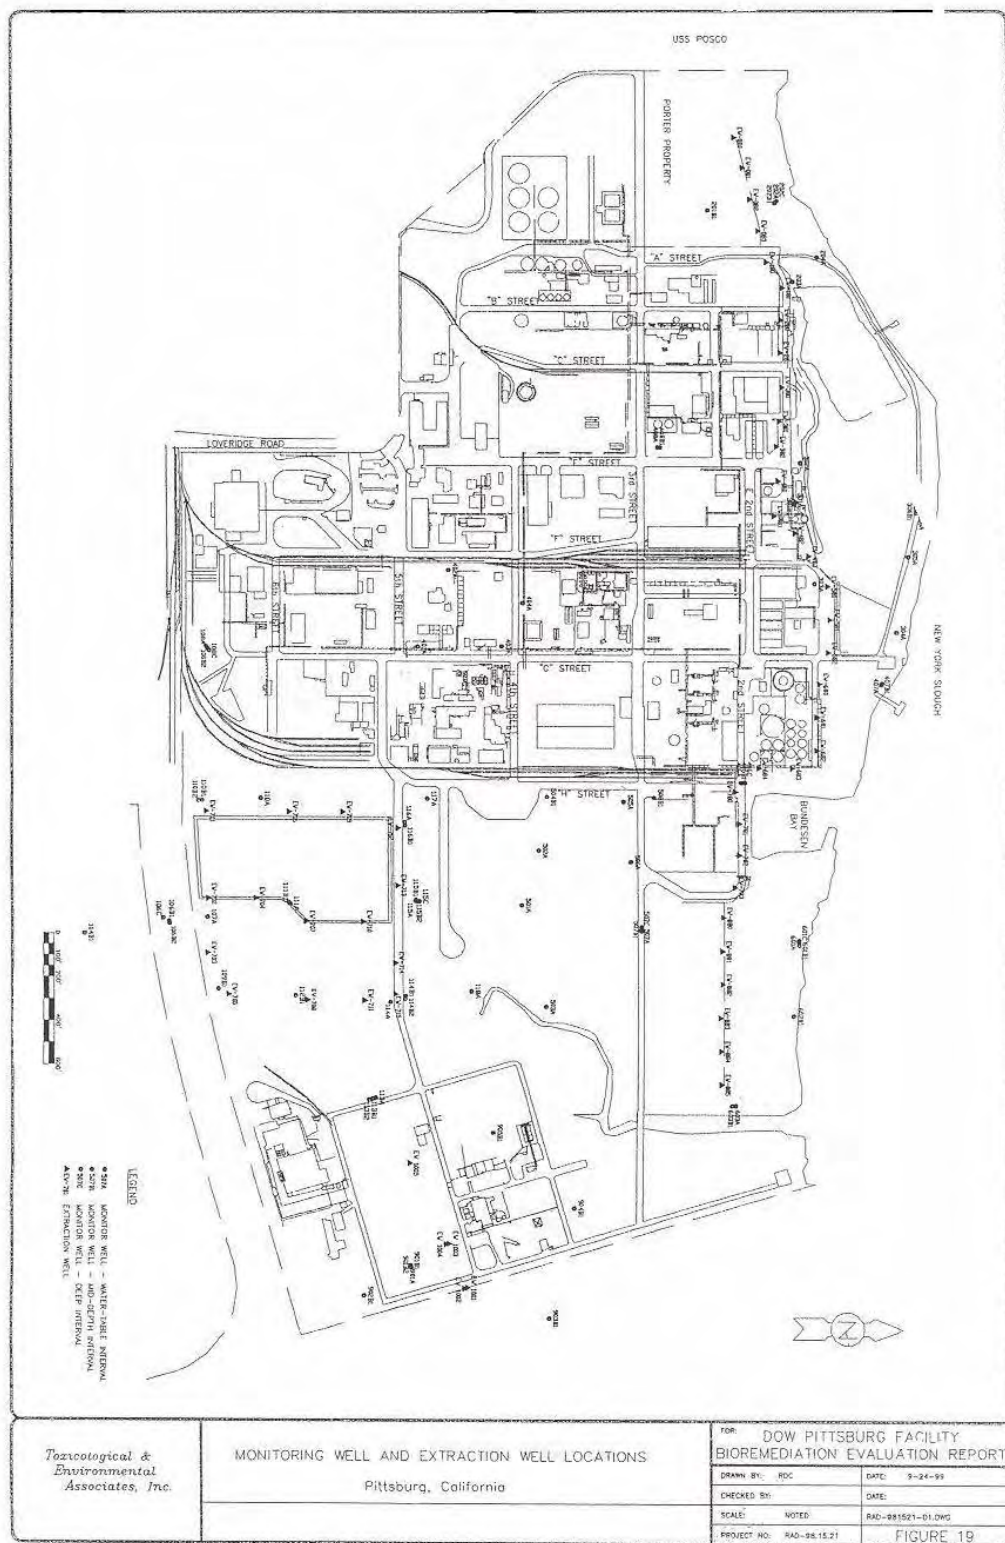
Figure 4-40. Site Layout with Monitoring and Extraction Well Locations at the Dow Facility

The Dow Chemical Company (Dow) owns and operates a chemical manufacturing facility that occupies approximately 993 acres in Pittsburg, California (Figure 4-40). The site is bounded by the New York Slough on the north, the Pittsburg-Antioch Highway on the south, Loveridge Road on the west, and parklands and commercial areas on the east. Residential areas exist further to the south beyond the Antioch-Pittsburg Highway.

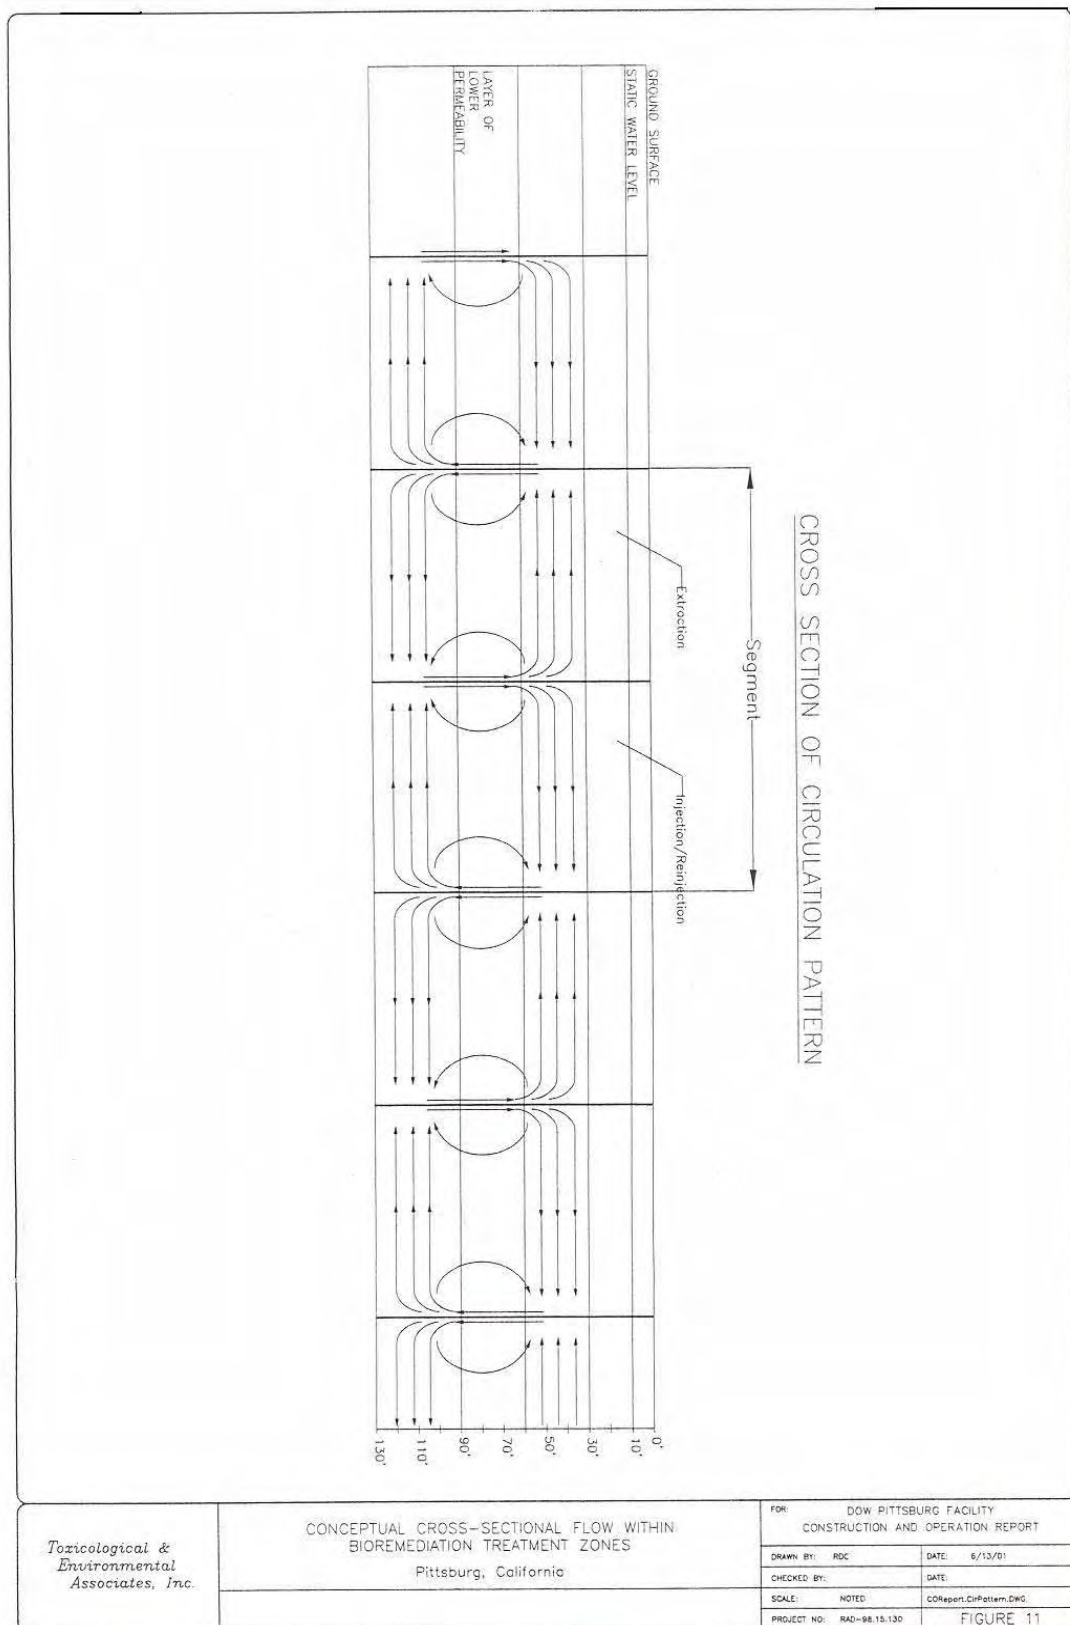
Figure 4-41. Groundwater Circulation Pattern Induced by Circulation Wells at the Dow Facility

Using a pump string with inflatable packers inside each well, groundwater was extracted through one of the two well screens, mixed with liquid amendments, then forced (under pressure) back into the formation through the other well screen. Wells in which groundwater was extracted from the deep interval and circulated back into the mid-depth interval were termed “*up-pumping wells*.” Conversely, wells where the groundwater was extracted from the mid-depth interval and circulated back into the deep interval were termed “*down-pumping wells*.” Within each bioremediation zone the order of up-pumping and down-pumping wells alternates linearly. The linear circulation well pattern was intended to form extended zones of enhanced bioremediation by creating contiguous cells of circulating amended groundwater. Figure 4-41 illustrates the circulation pattern for the bioremediation zone cross section.

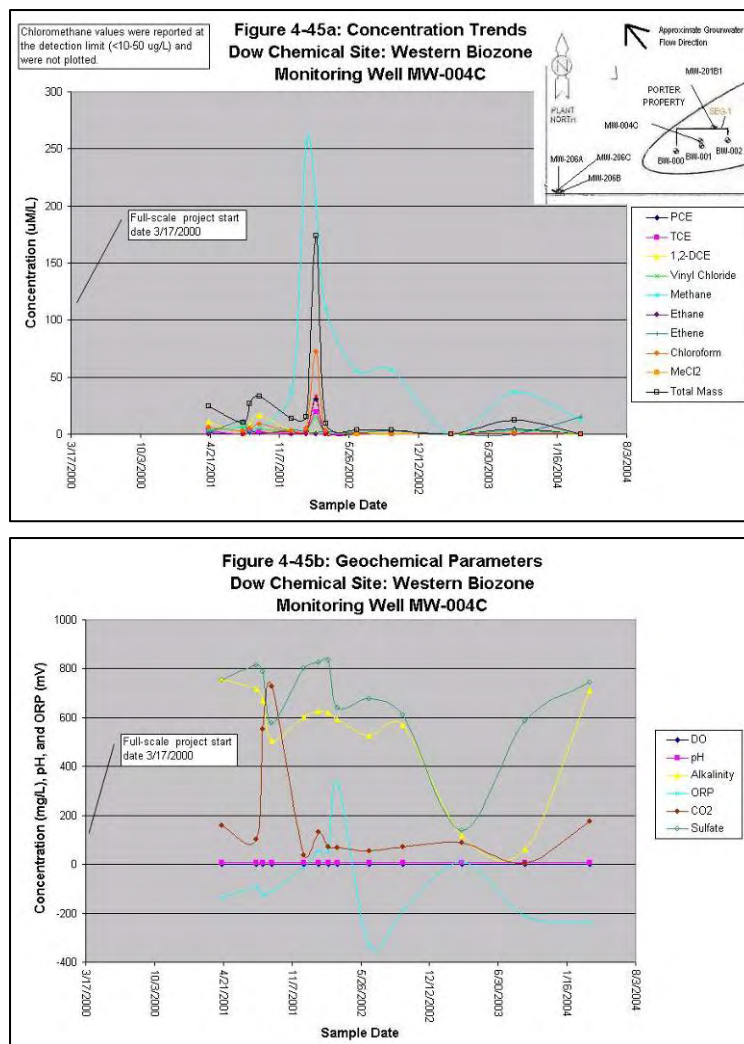
Monitoring Well	Contaminant Mass Loss								Enhanced Geochemical Condition	Elevated Dissolved Gases	Biodegradation Rating
	PCE	TCE	DCE	VC	CCl ₄	CF	MeCl ₂	CM			
MW-004C		+	+	+	+				+	+	HE

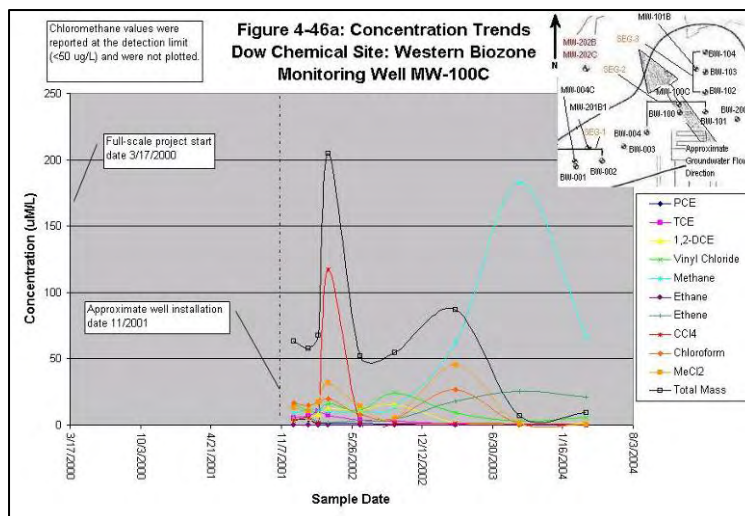
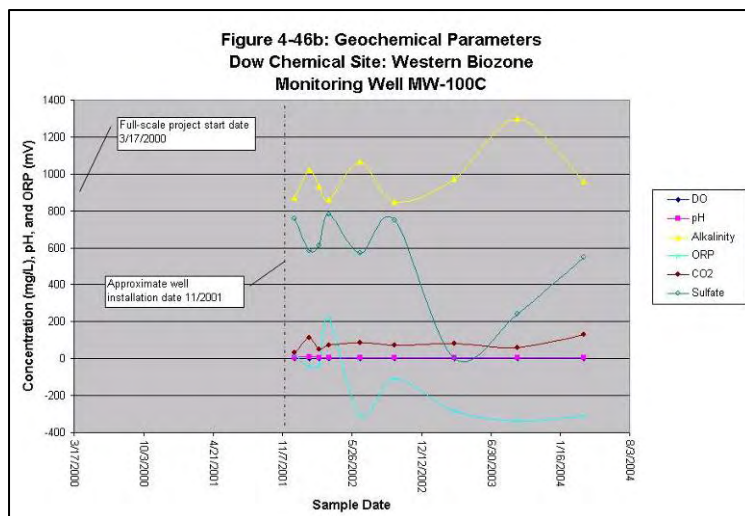
Monitoring Well	Contaminant Mass Loss								Enhanced Geochemical Condition	Elevated Dissolved Gases	Biodegradation Rating
	PCE	TCE	DCE	VC	CCl ₄	CF	MeCl ₂	CM			
MW-100C	+	+	+	+	+	+	+		+	-	HE

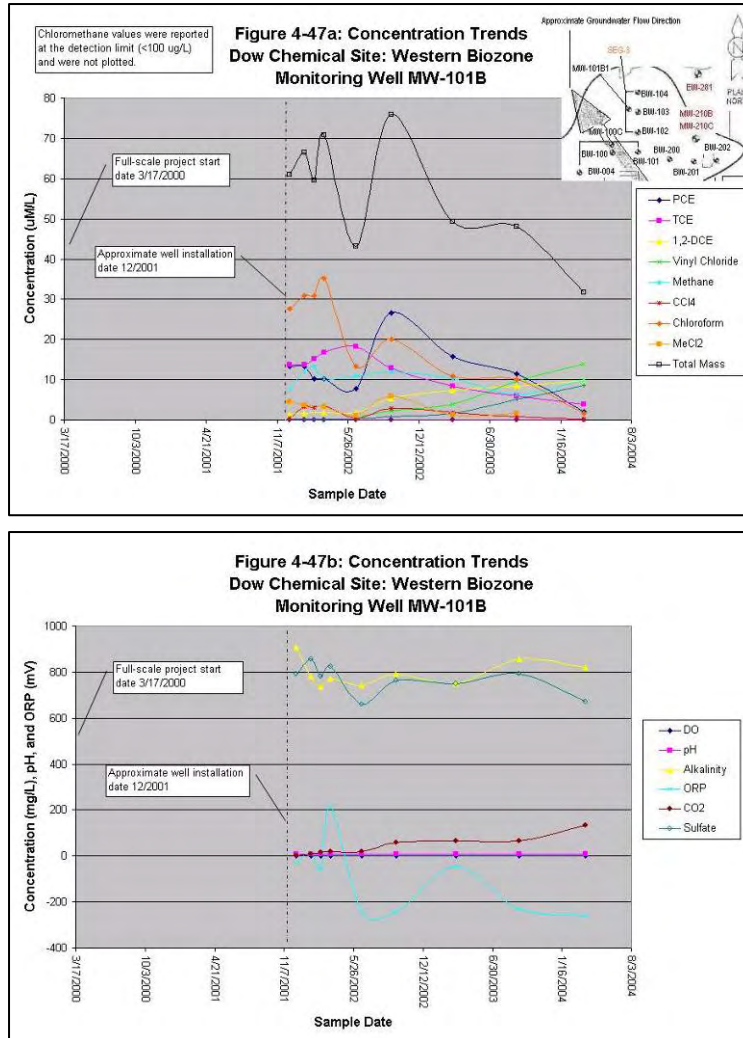
Monitoring Well	Contaminant Mass Loss								Enhanced Geochemical Condition	Elevated Dissolved Gases	Biodegradation Rating
	PCE	TCE	DCE	VC	CCl ₄	CF	MeCl ₂	CM			
MW-101B	+	+	-	-	+	+	+		+	+	HE

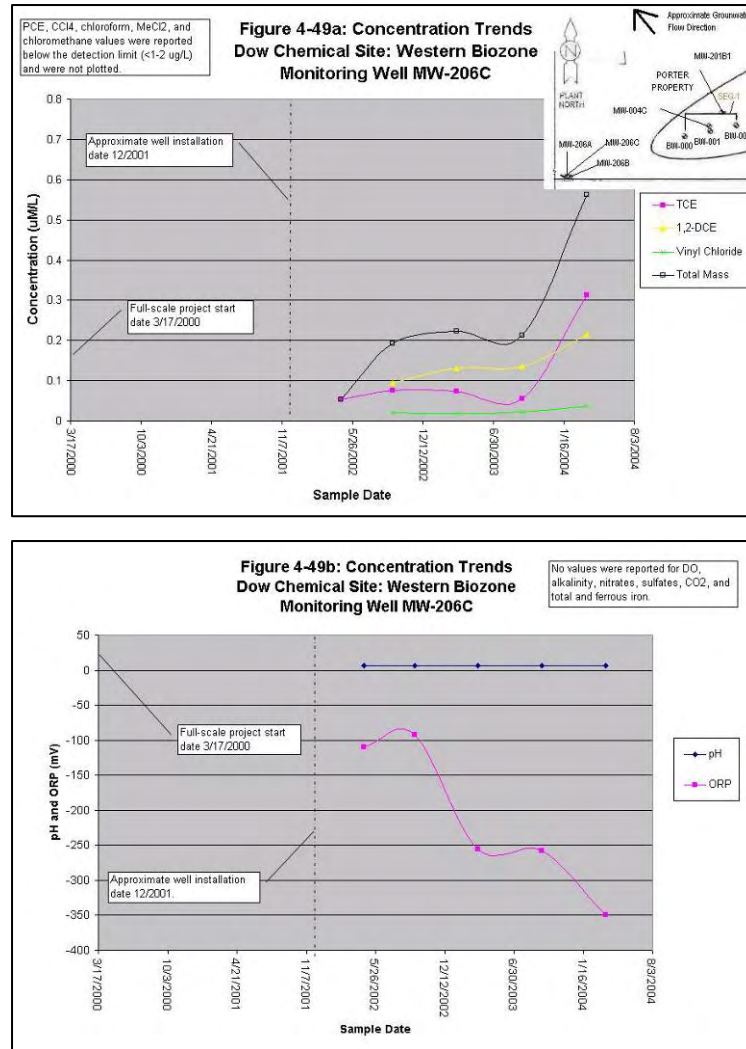
Figure 4-49. Data Analyses for MW-206C in the Western Biozone

MW-206B and MW-206C (background wells, located west of the biozone). Each well only had five data points for a two-year period. No data were available on the geochemical, dissolved gas, or electron acceptor parameters at either well. An overall increase was observed at MW-206B due to an increase in CCl₄ concentration (see Figure 4-48). PCE and chloroform concentrations did not change nor were the daughter products of PCE detected. At MW-206C, overall contaminant concentrations increased slightly due to increases in 1,2-DCE and TCE while vinyl chloride concentrations did not change (refer to Figure 4-49).

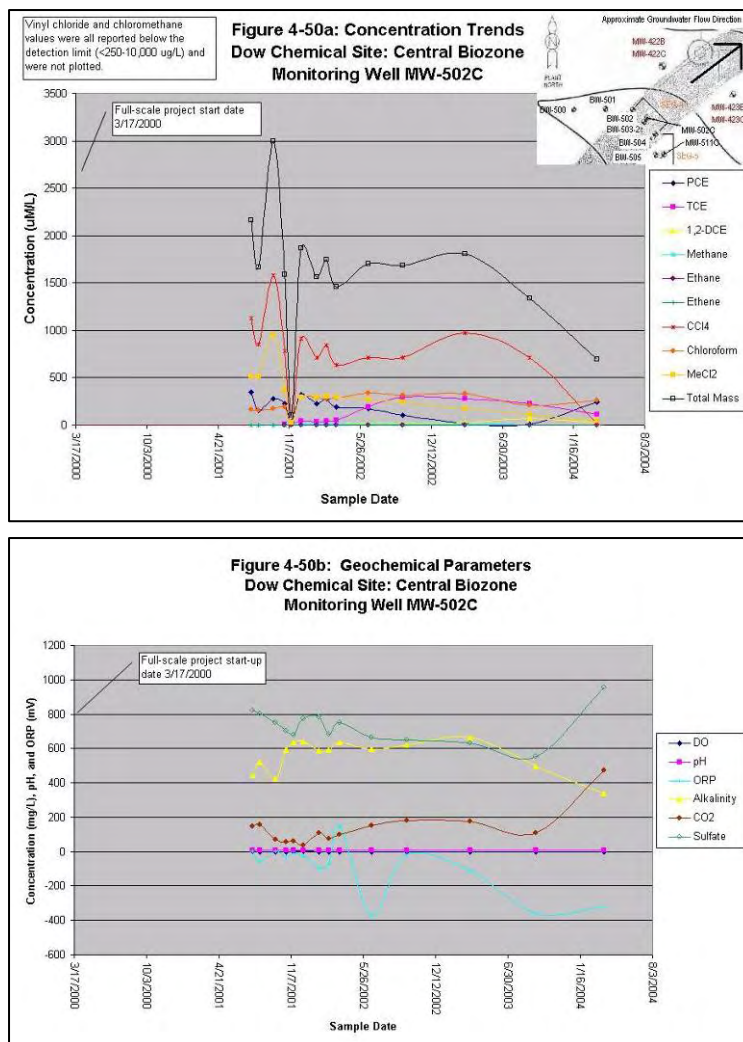
Monitoring Well	Contaminant Mass Loss								Enhanced Geochemical Condition	Elevated Dissolved Gases	Biodegradation Rating
	PCE	TCE	DCE	VC	CCl ₄	CF	MeCl ₂	CM			
MW-502C	-	-				+	0		+	+	HE

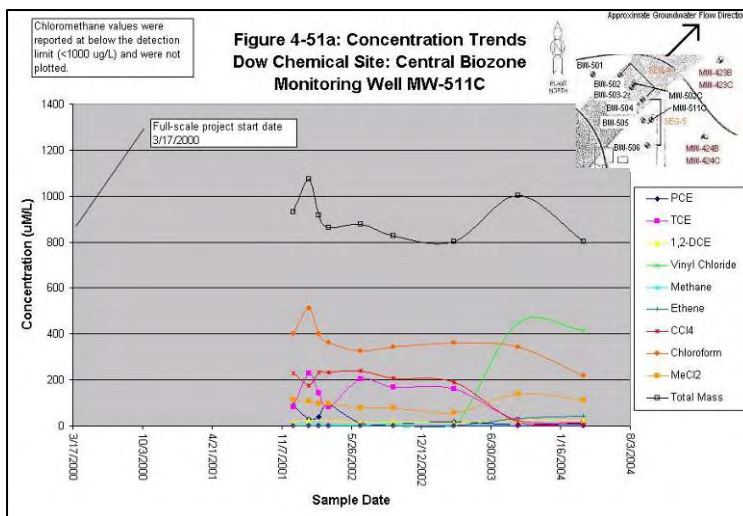
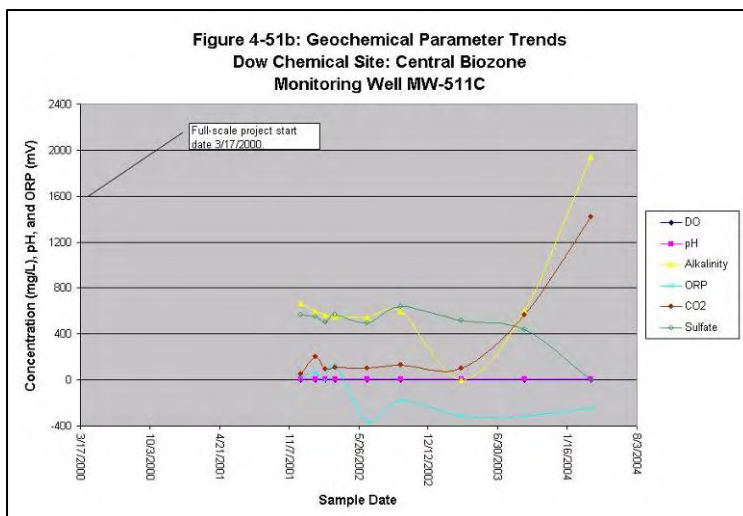
Monitoring Well	Contaminant Mass Loss								Enhanced Geochemical Condition	Elevated Dissolved Gases	Biodegradation Rating
	PCE	TCE	DCE	VC	CCl ₄	CF	MeCl ₂	CM			
MW-511C	0	+	0	-	+	+	0		+	+	HE

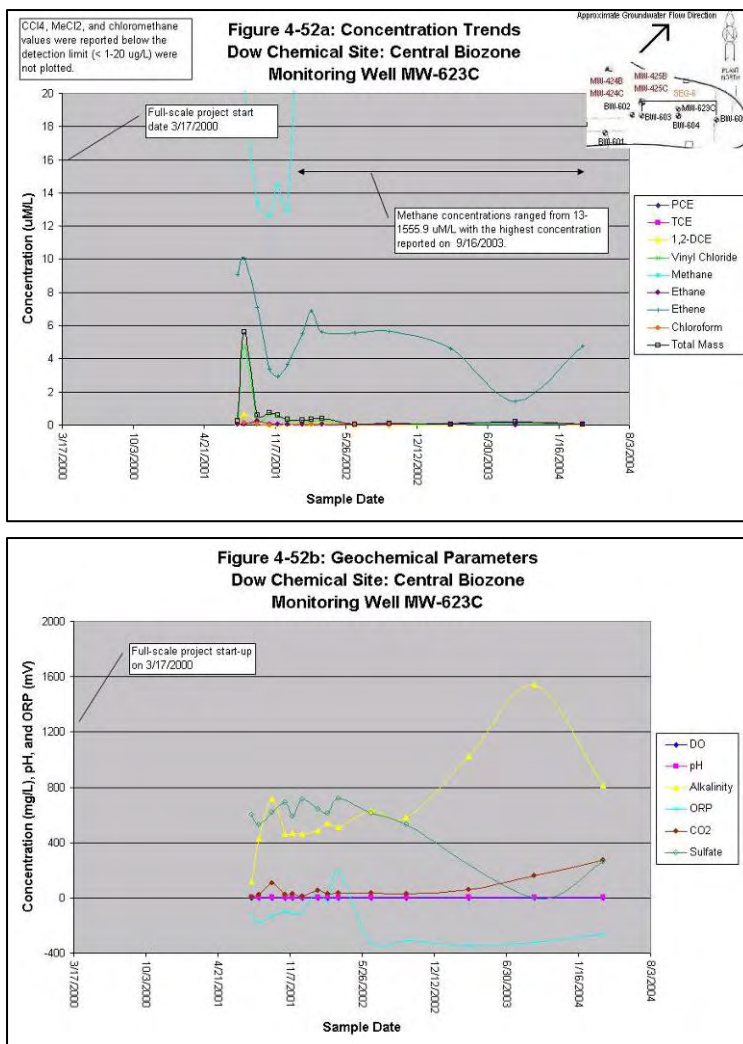
Monitoring Well	Contaminant Mass Loss								Enhanced Geochemical Condition	Elevated Dissolved Gases	Biodegradation Rating
	PCE	TCE	DCE	VC	CCl ₄	CF	MeCl ₂	CM			
MW-623C	0	0	0	0		0			+	-	SE

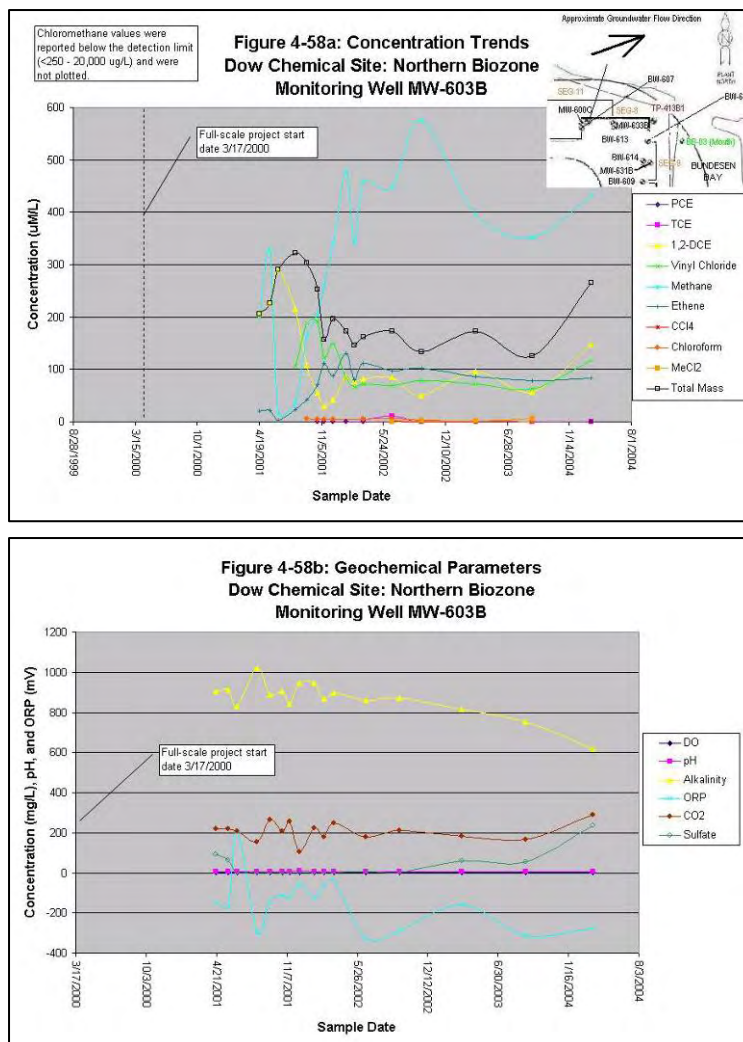
Monitoring Well	Contaminant Mass Loss								Enhanced Geochemical Condition	Elevated Dissolved Gases	Biodegradation Rating
	PCE	TCE	DCE	VC	CCl ₄	CF	MeCl ₂	CM			
MW-603B	0	0	-	-	0	0	0		+	-	SE

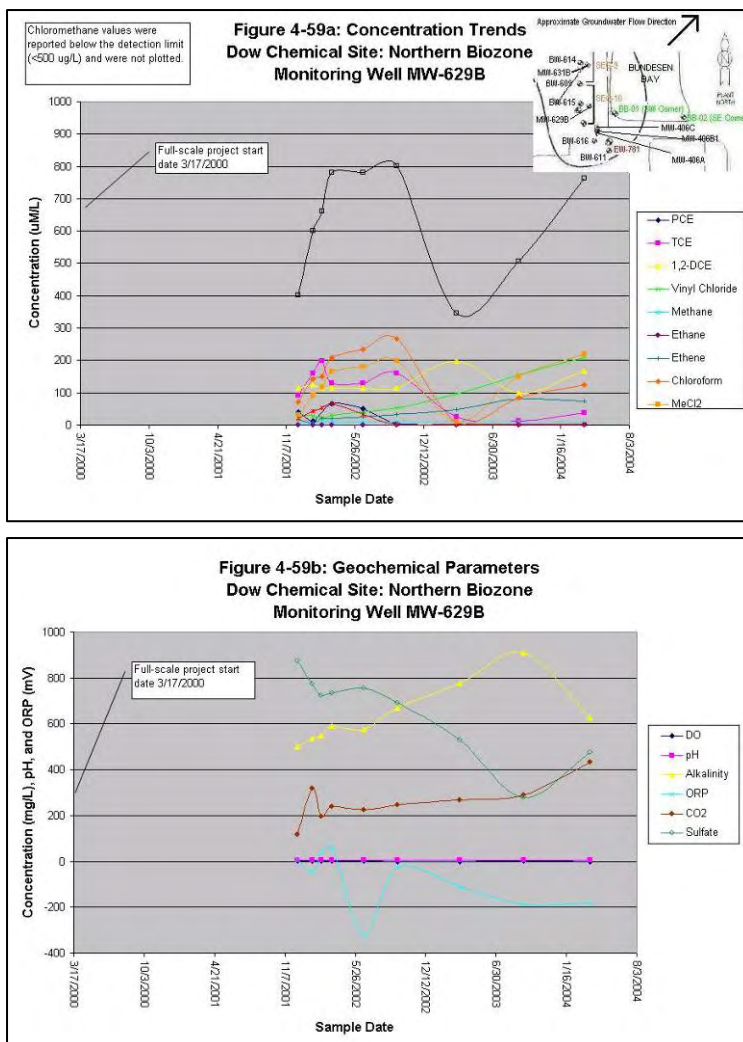
Monitoring Well	Contaminant Mass Loss								Enhanced Geochemical Condition	Elevated Dissolved Gases	Biodegradation Rating
	PCE	TCE	DCE	VC	CCl ₄	CF	MeCl ₂	CM			
MW-629B	+	+	-	-	+				+	-	ME

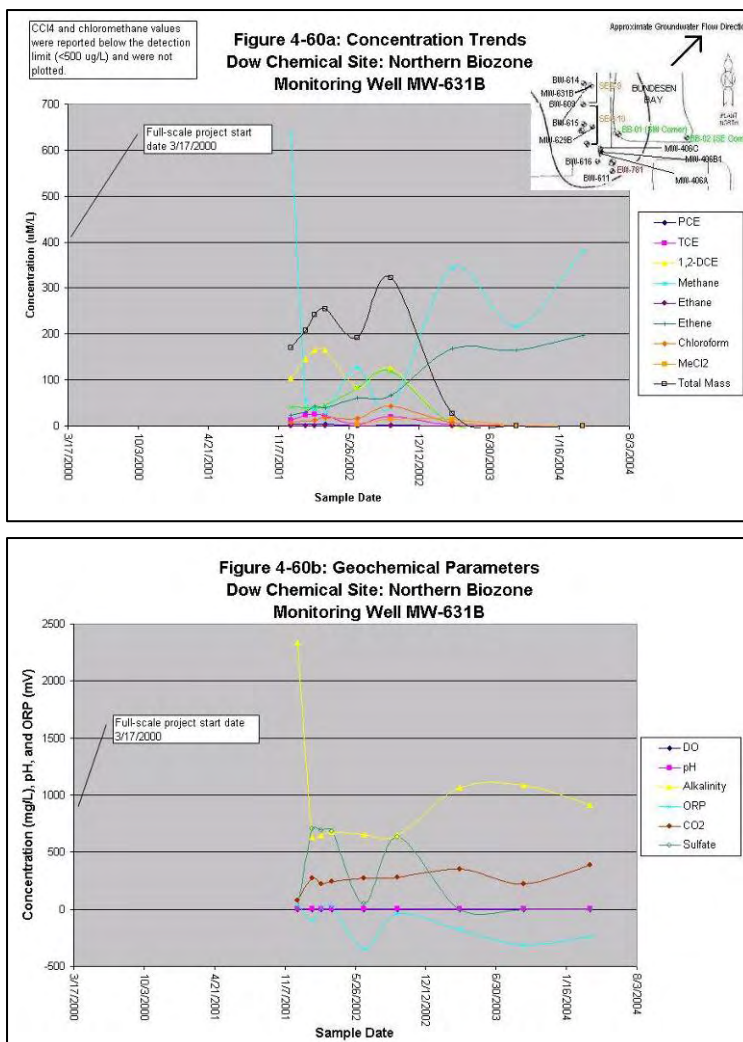
Monitoring Well	Contaminant Mass Loss								Enhanced Geochemical Condition	Elevated Dissolved Gases	Biodegradation Rating
	PCE	TCE	DCE	VC	CCl ₄	CF	MeCl ₂	CM			
MW-631B	+	+	+	+	0	+	0		+	+	HE

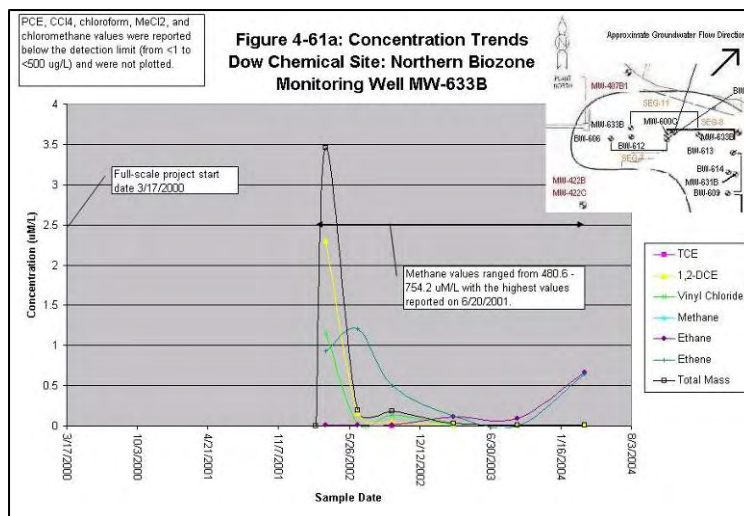
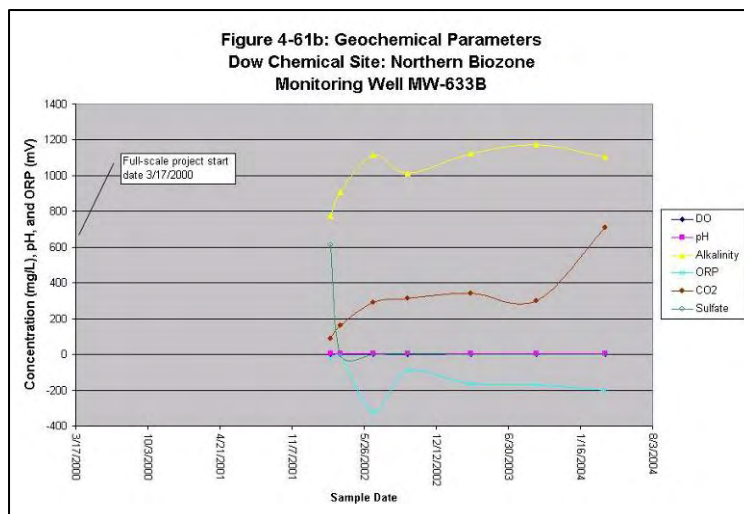
Monitoring Well	Contaminant Mass Loss								Enhanced Geochemical Condition	Elevated Dissolved Gases	Biodegradation Rating
	PCE	TCE	DCE	VC	CCl ₄	CF	MeCl ₂	CM			
MW-633B		0	-	-					+	+	ME
